1. Scope of Test

This report was a record of a fire resistance test conducted by Forte Testing and Consultants Co., Ltd, in conformity with requirements in *BS EN 1364-1: 1999 "Fire resistance tests for non-loadbearing elements – Part 1: Walls"* and particular requirements in *BS EN 1363-1: 1999 "Fire resistance tests – Part 1: General requirements"*.

The test subject was a gypsum block wall of an overall size 3000 mm width by 3040 mm height. The specimen was built with "Jumbo" gypsum blocks jointed together with "Jumbo" premixed gypsum bonding adhesive. The specimen was supplied for test by Fujian Jumbo New Material Corporation Limited, supplier of the specimen.

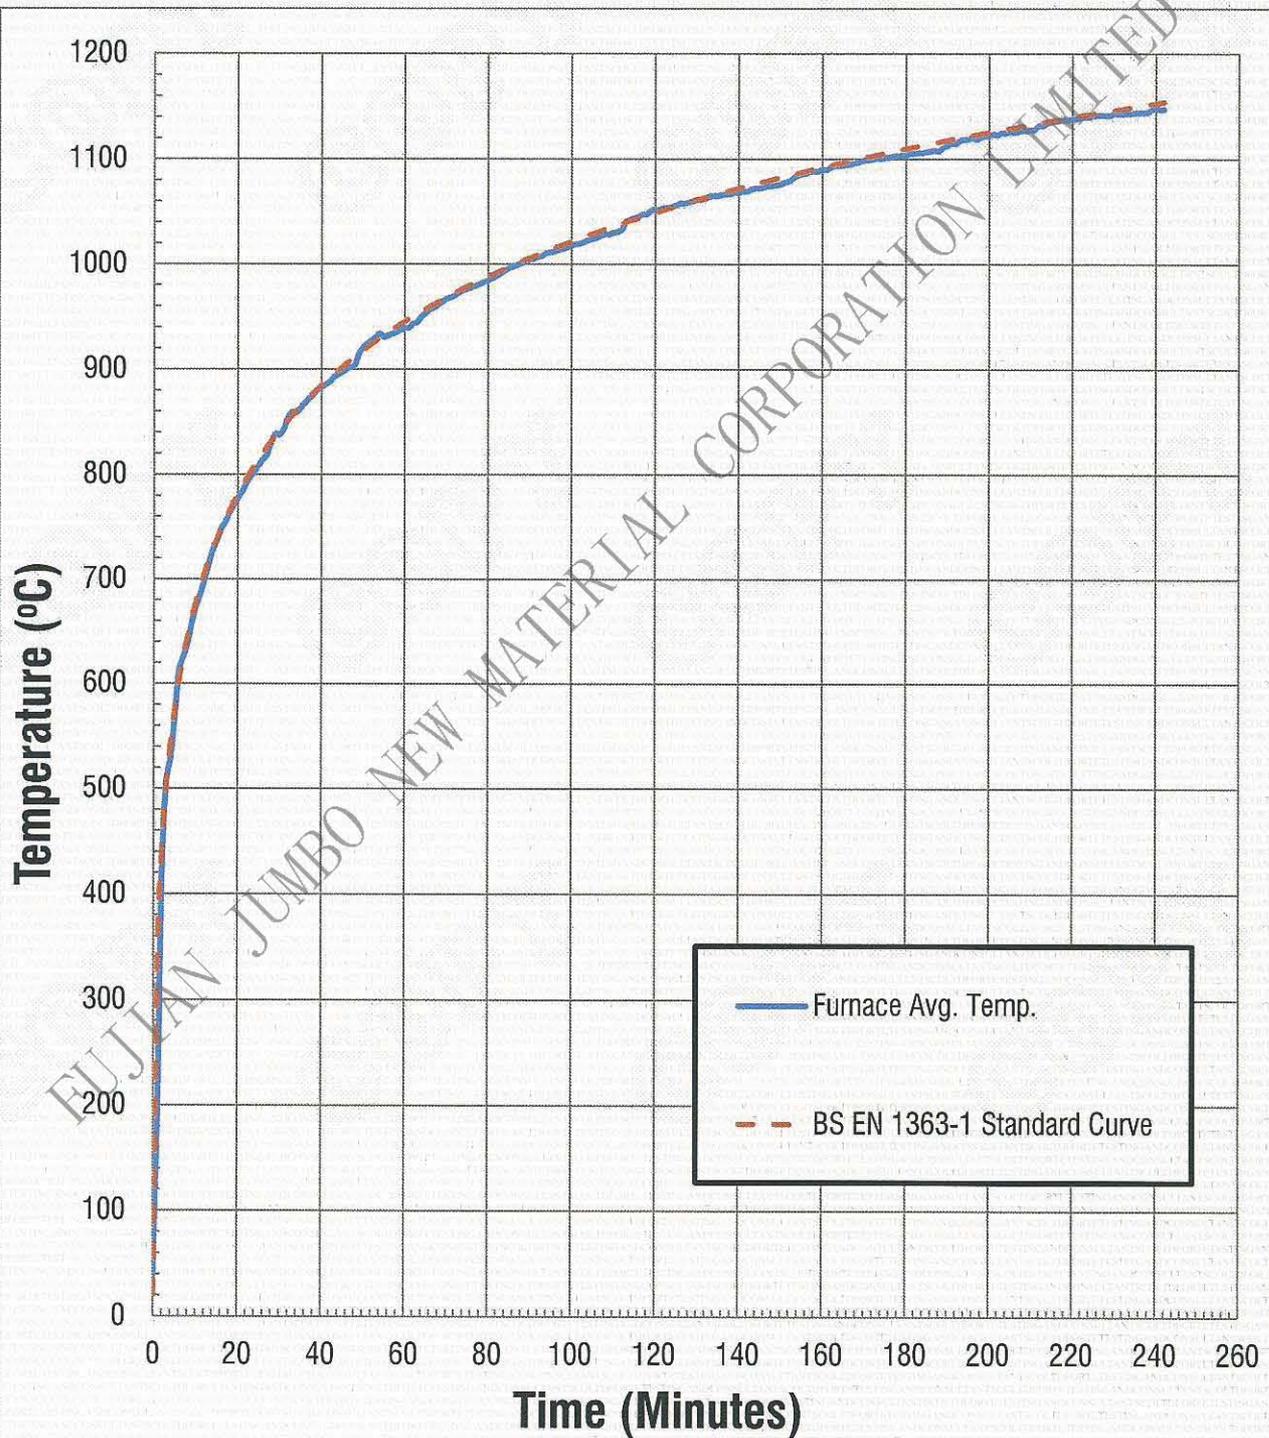
Figure 3. Furnace average temperature over the test period.

The average temperature inside the furnace was monitored and controlled throughout the test according to the standard heating curve stated in *BS EN 1363-1:1999* given by the equation:

The furnace average temperature over the test period was shown in *Figure 3*.

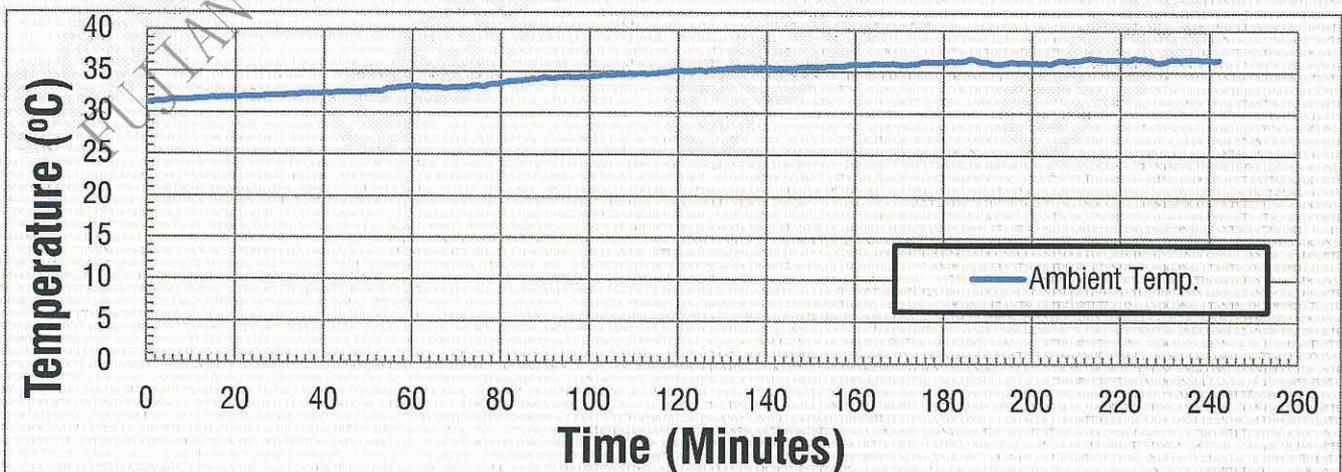
Figure 5. Ambient temperature over the test period.

The ambient temperature over the test period was recorded and was shown in *Figure 5*. The ambient temperature at the commencement of test was 31.2°C.

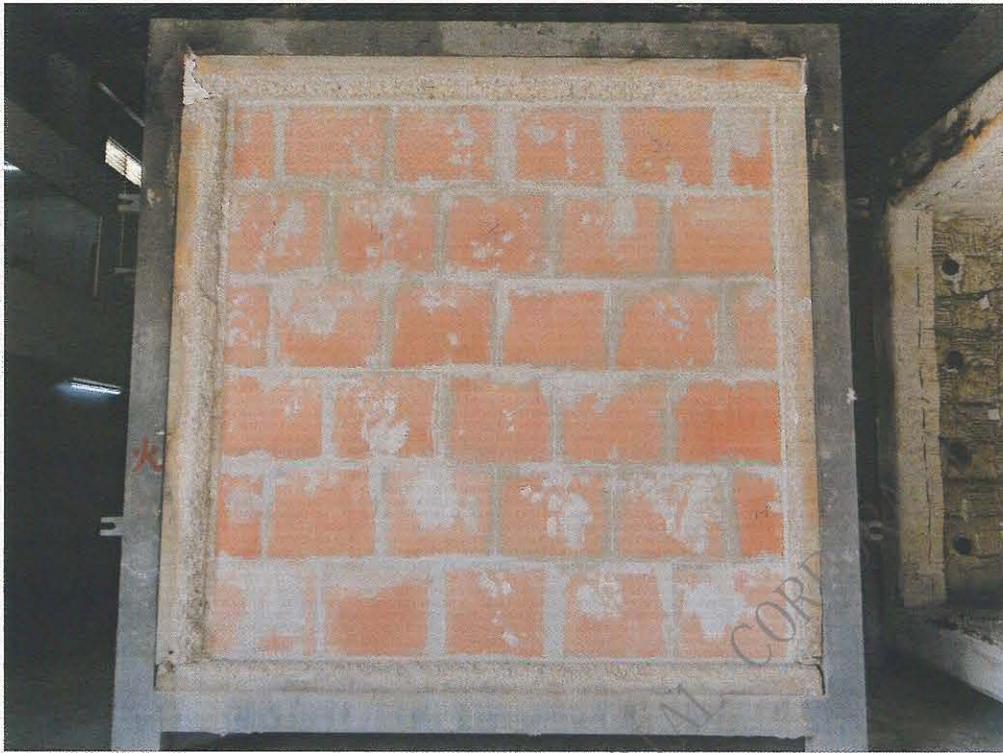
Photo 1. Exposed surface of the specimen before test.

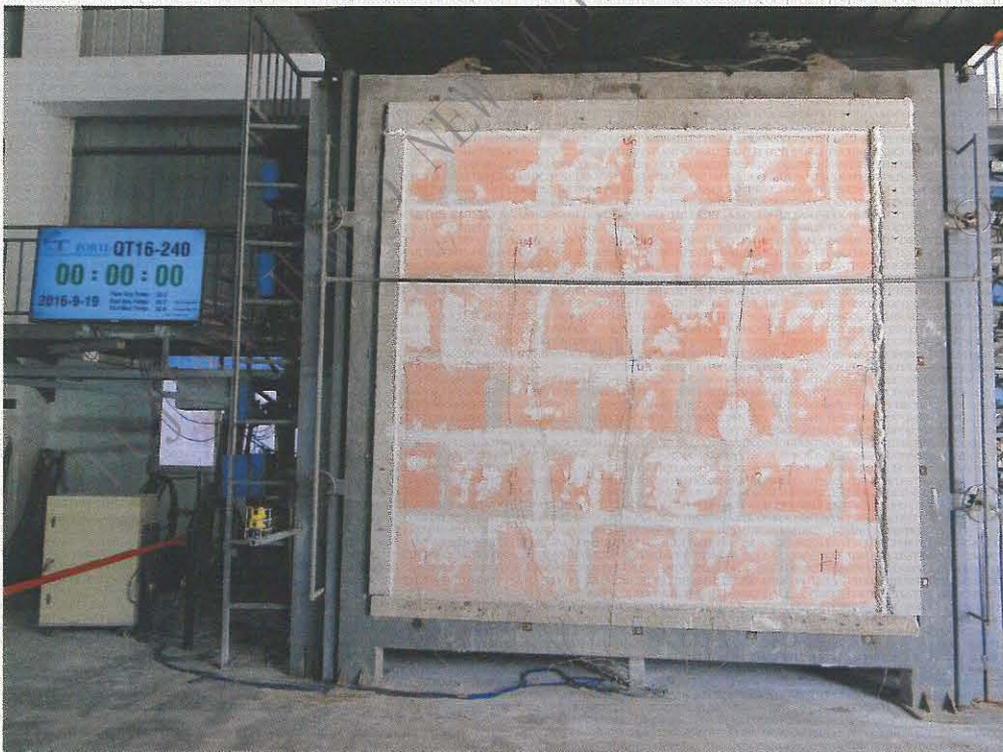
Photo 2. Unexposed surface of the specimen before the commencement of test.

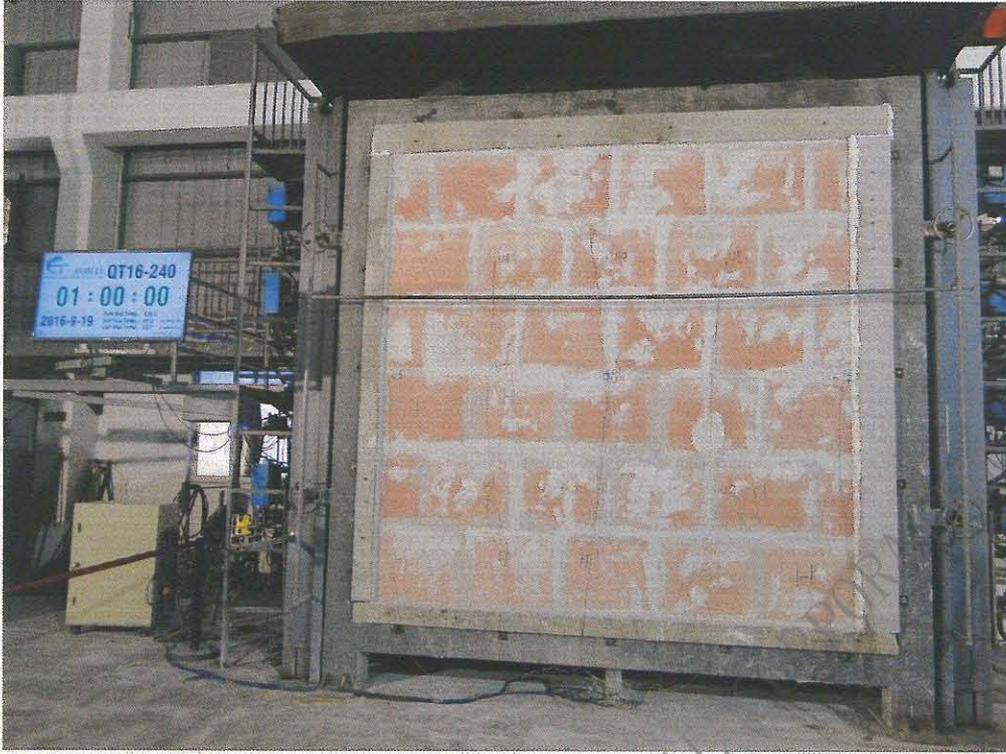
Photo 5. Unexposed surface of the specimen at 60 minutes of test.

60.00	NO INTEGRITY FAILURE HAD OCCURRED.
75.37	The sizes of the crack mentioned on 12.16 minute of test reduced.
90.00	NO INTEGRITY FAILURE HAD OCCURRED.

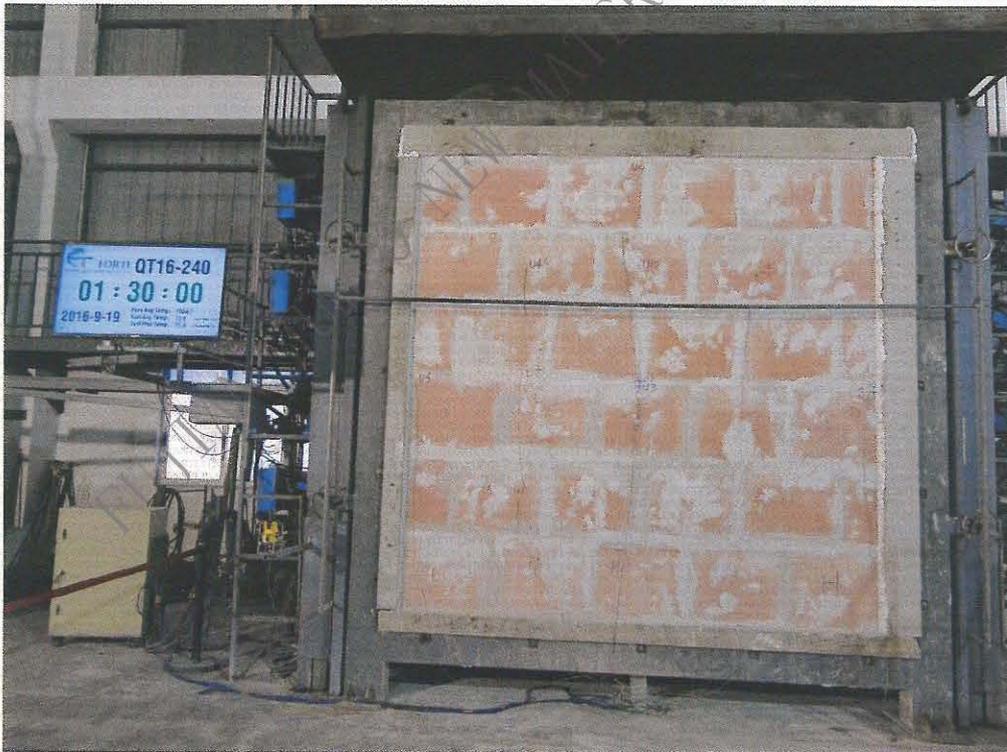
Photo 6. Unexposed surface of the specimen at 90 minutes of test.

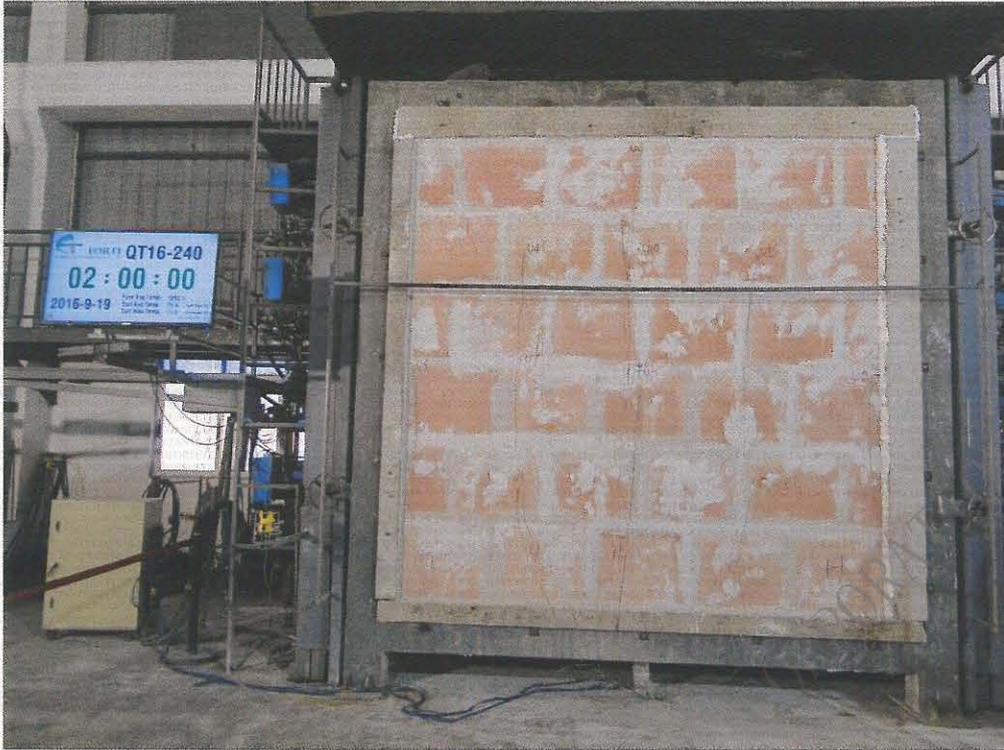
Photo 7. Unexposed surface of the specimen at 120 minutes of test.

110.00	No significant changes were observed from the specimen.
120.00	NO INTEGRITY FAILURE HAD OCCURRED.
135.00	The centre of the specimen bended slightly outward away from the furnace.

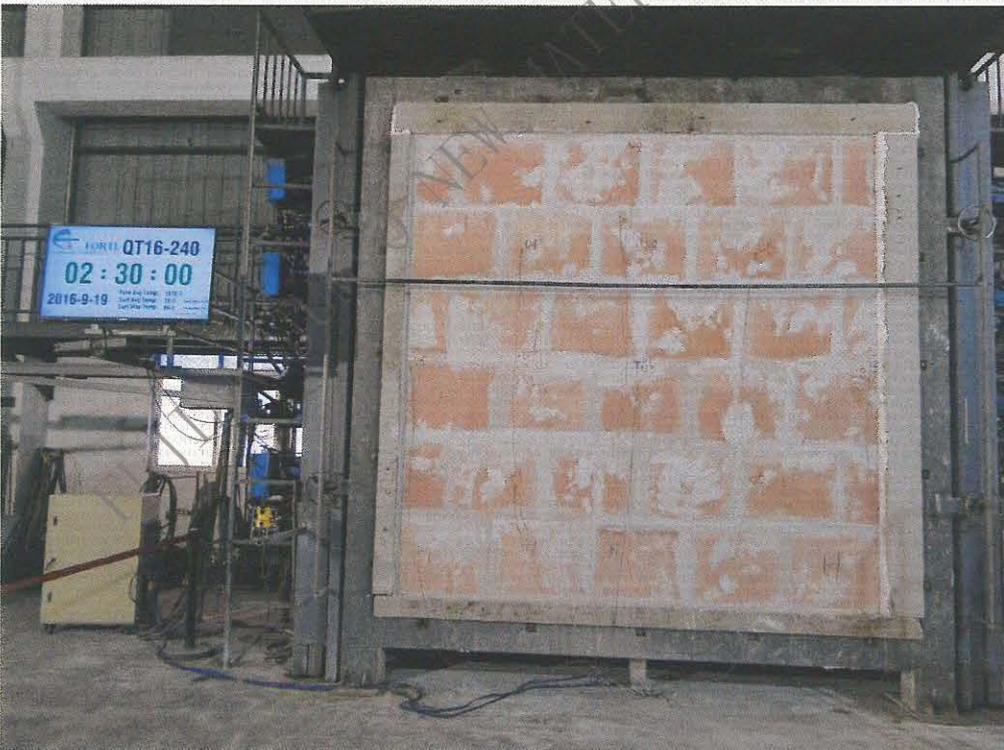
Photo 8. Unexposed surface of the specimen at 150 minutes of test.

150.00	NO INTEGRITY FAILURE HAD OCCURRED.
164.15	Horizontal crack appeared along the joint between the 2 nd and 3 rd course of gypsum block from sill level at left portion of the specimen.

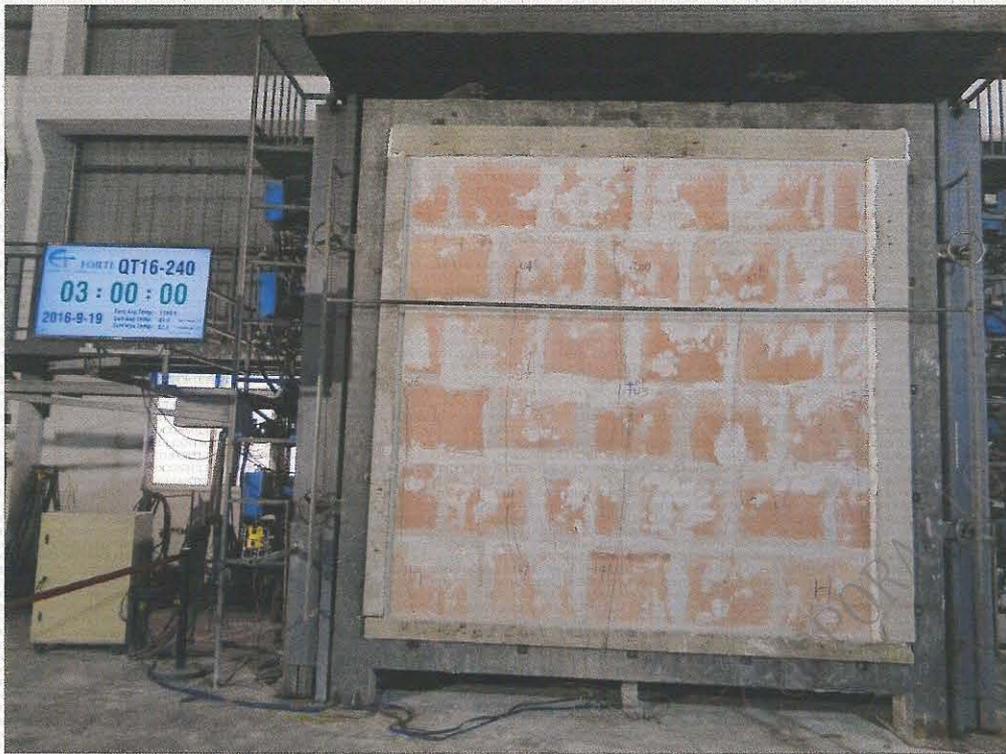
Photo 9. Unexposed surface of the specimen at 180 minutes of test.

180.00	NO INTEGRITY FAILURE HAD OCCURRED.

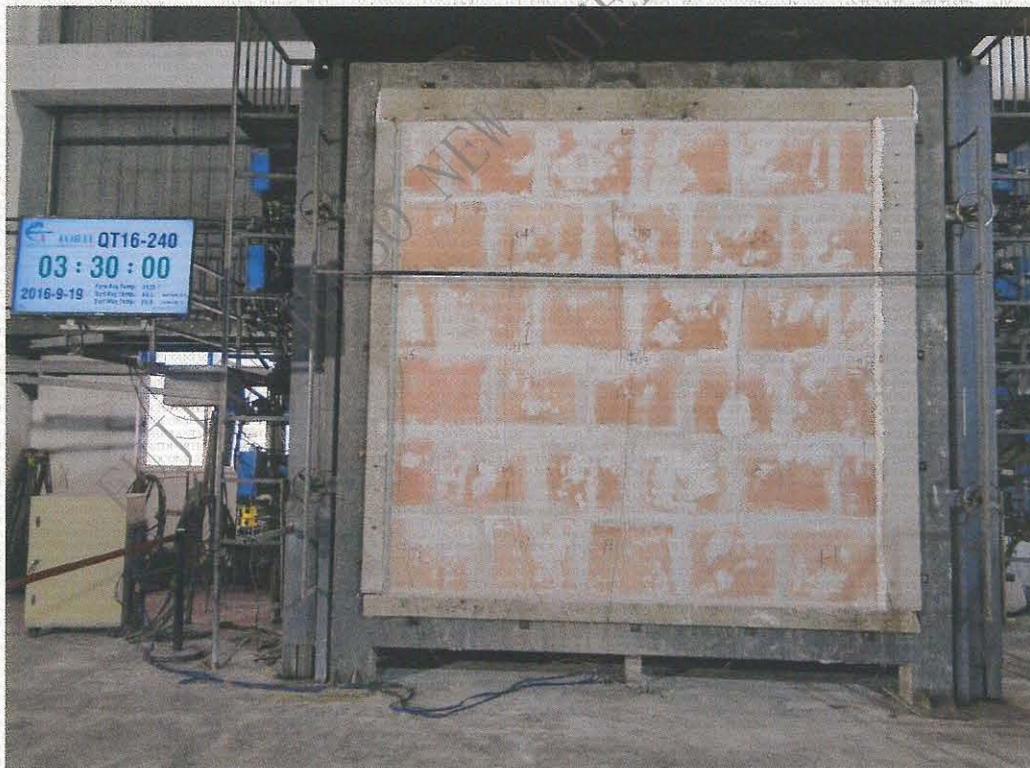
Photo 10. Unexposed surface of the specimen at 210 minutes of test.

210.00	NO INTEGRITY FAILURE HAD OCCURRED.
212.27	Vertical creak appeared across the gypsum block at the centre of the 3 rd course from the sill level.
216.30	Cotton fibre pad test was carried out on crack mentioned at 164.15 minute of test. No flaming or glowing on the cotton pad was observed.

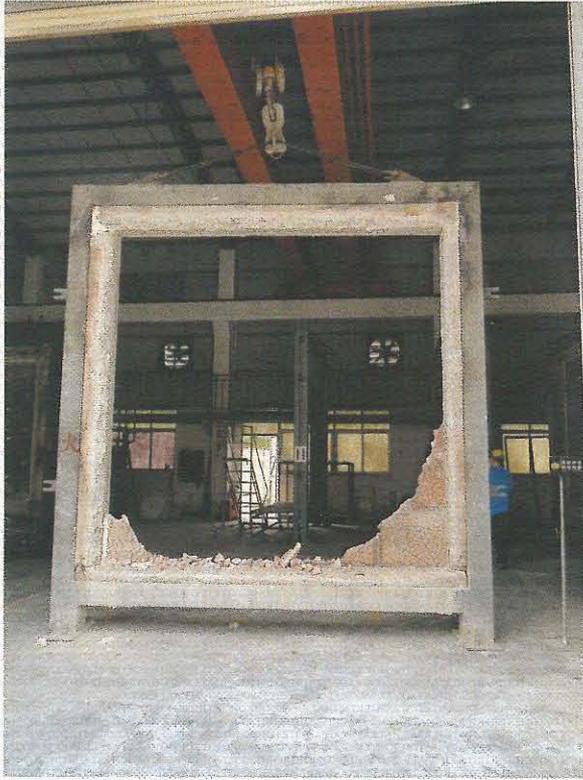
Photo 13. Fire exposed side of a portion of the specimen on the test rig after the test.
