<b>Test Report No.:</b>	<b>Q19A195</b>
<b>Date of Issue :</b>	<b>November 18, 2019</b>
<b>Revision :</b>	<b>00</b>

## Fire Resistance Test Report for Jumbo Gypsum Block Wall

Sponsor:	Mercurio Servicos De Engenharia Companhia Limitada.
Address:	Patio Da Concordia No 5-43, Fabrica Wang Kai 9 Andar A, Macau.
<b>Information provided by Sponsor</b>	
Product Name:	Jumbo Gypsum Block Wall (Non-Loadbearing)
Nominal dimension:	600(L)*500(H) *100mmT(Sample), 3.00m×3.00m(Wall)
Test Specimen Layout:	See <b>Appendix 1</b>
<b>Details of Test and Results</b>	
Test Method:	ASTM E119-18a: Standard Test Methods for Fire Tests of Building Construction and Materials
Date of Test:	Oct 31th, 2019
Test Results:	The test specimen has withstood the fire-resistance test without passage of flame or gases hot enough to ignite cotton waste, transmission of heat through the wall during the test was not raise the temperature on its unexposed surface more than 250°F (139°C) above its initial temperature for a period of 240 minutes, and there was no failure in the hose stream test. (Test was terminated upon sponsor request)

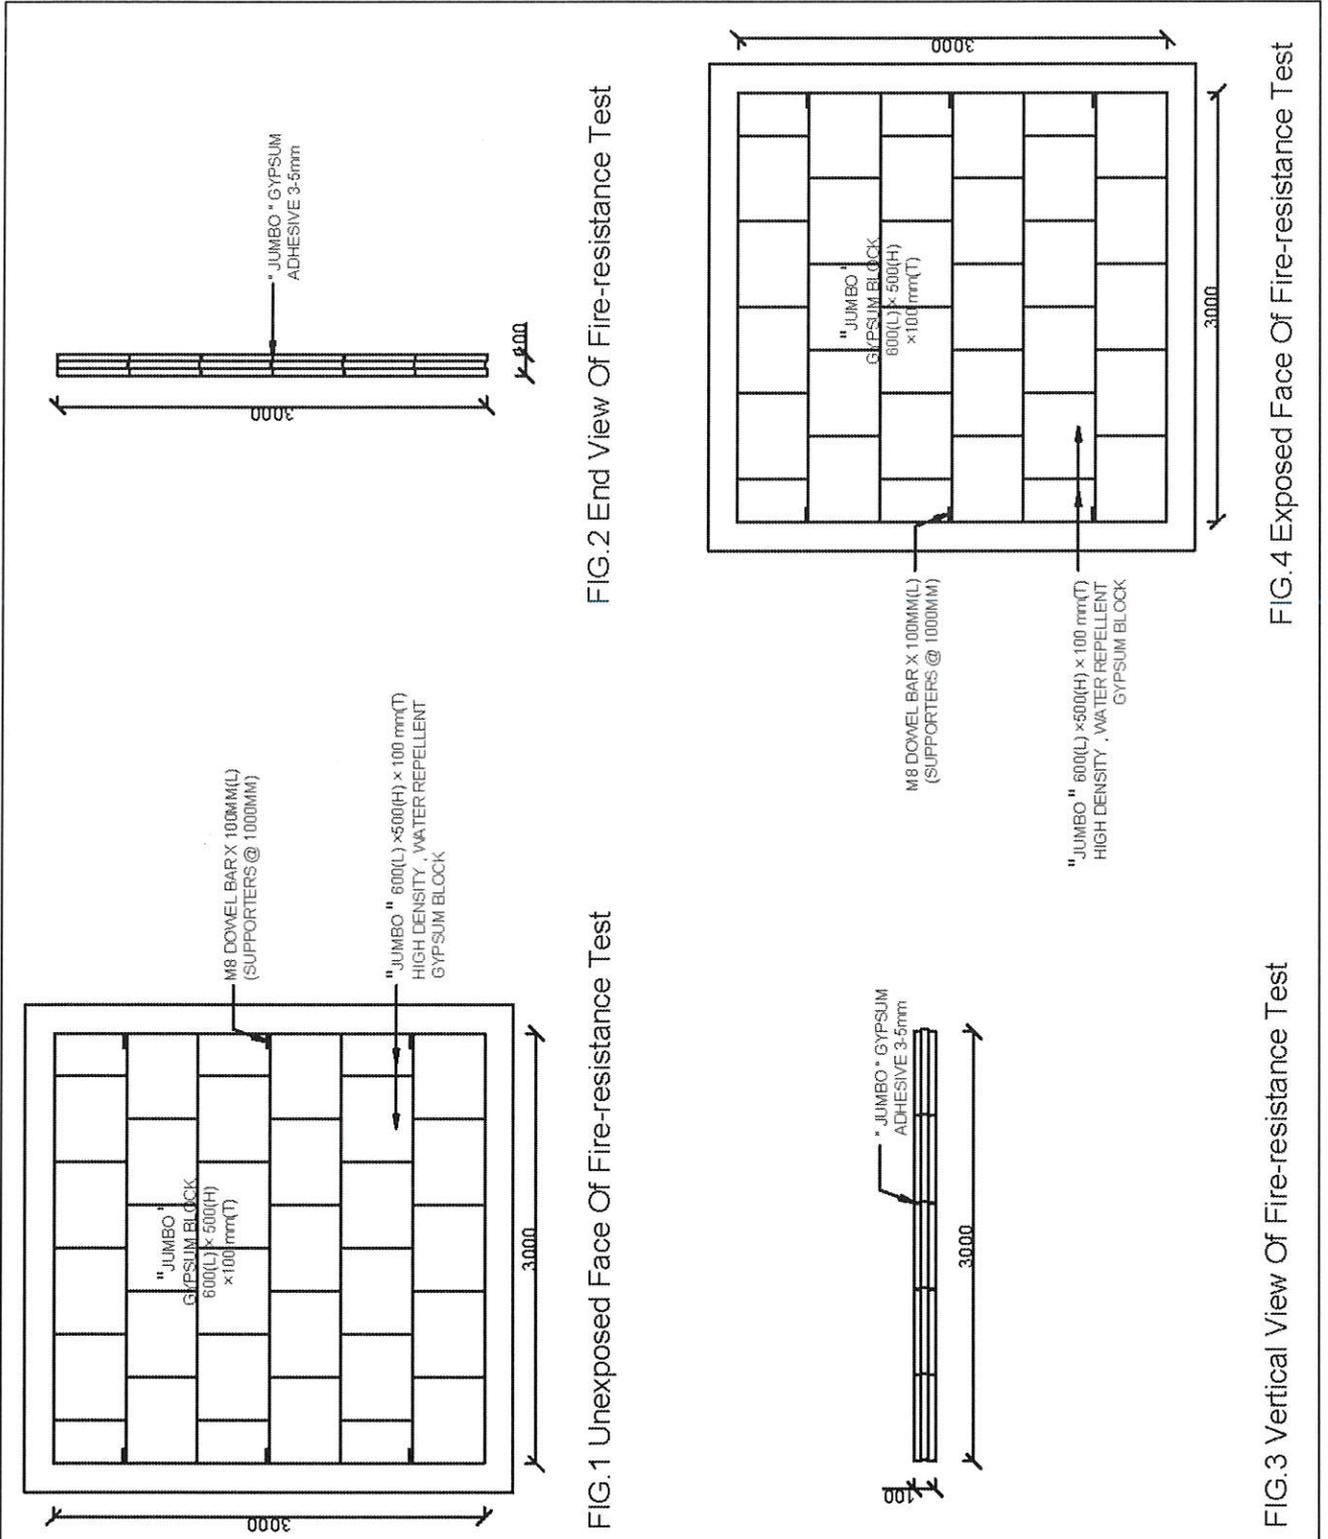
**Figure 1: Installation platform & samples layout of the specimen**

The fire resistance property of the panel wall on insulation & integrity elements was tested in Leading Edge Construction Materials Testing Company Limited Zhaoqing Laboratory (the Laboratory) in accordance with the requirements of **ASTM E119-18a**. The construction layout and the materials specification of the specimen are shown in the **Appendix 1**, which were provided by the Sponsor and the dimensions were verified by the Laboratory.

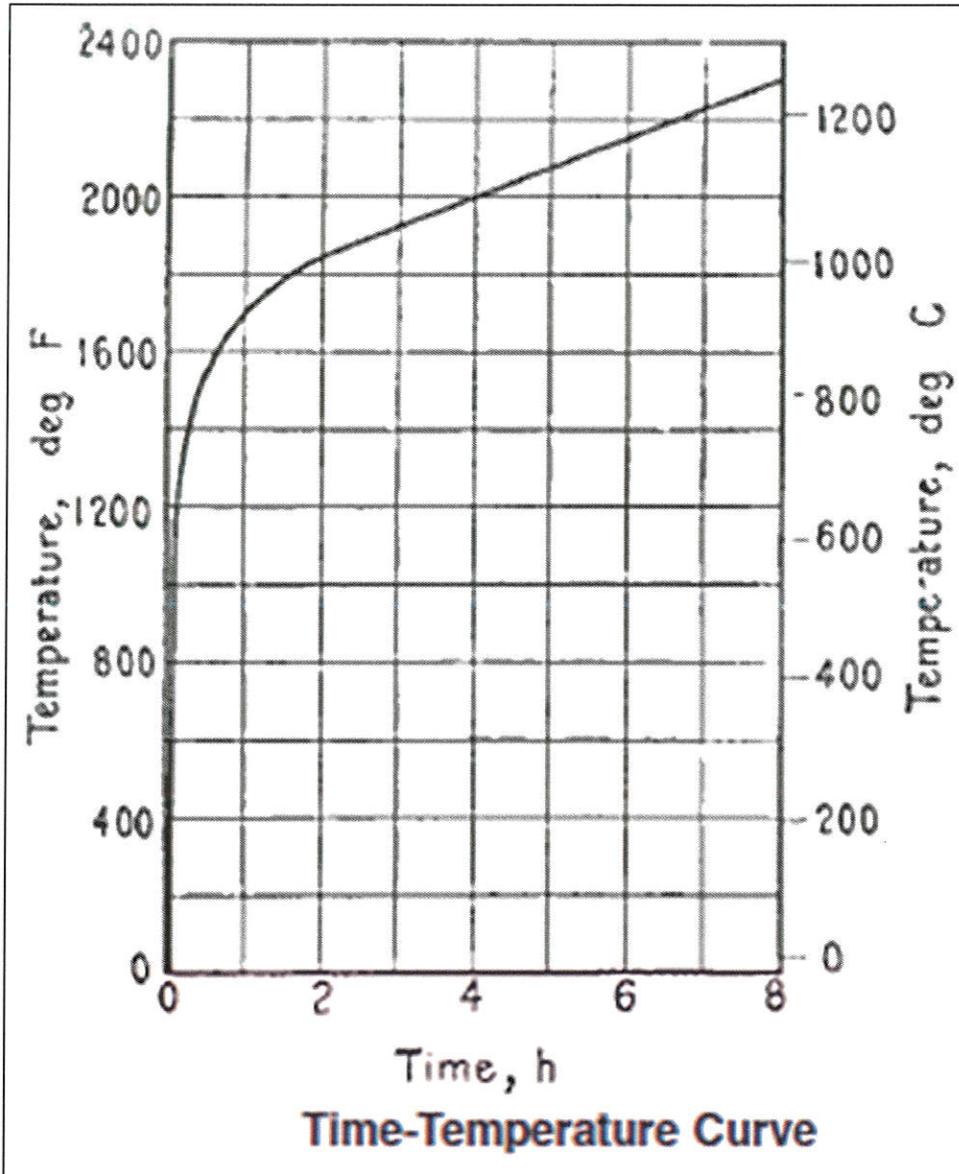
Figure 2: Standardized ASTM E119 Time vs. Temperature Curve

The test was conducted according to ASTM E119-18a. The standard measures the fire-resistance performance by quantifying the temperature rise on the unexposed face of the building element when the exposed side is subjected to the standardized ASTM E119 Time versus Temperature curve.

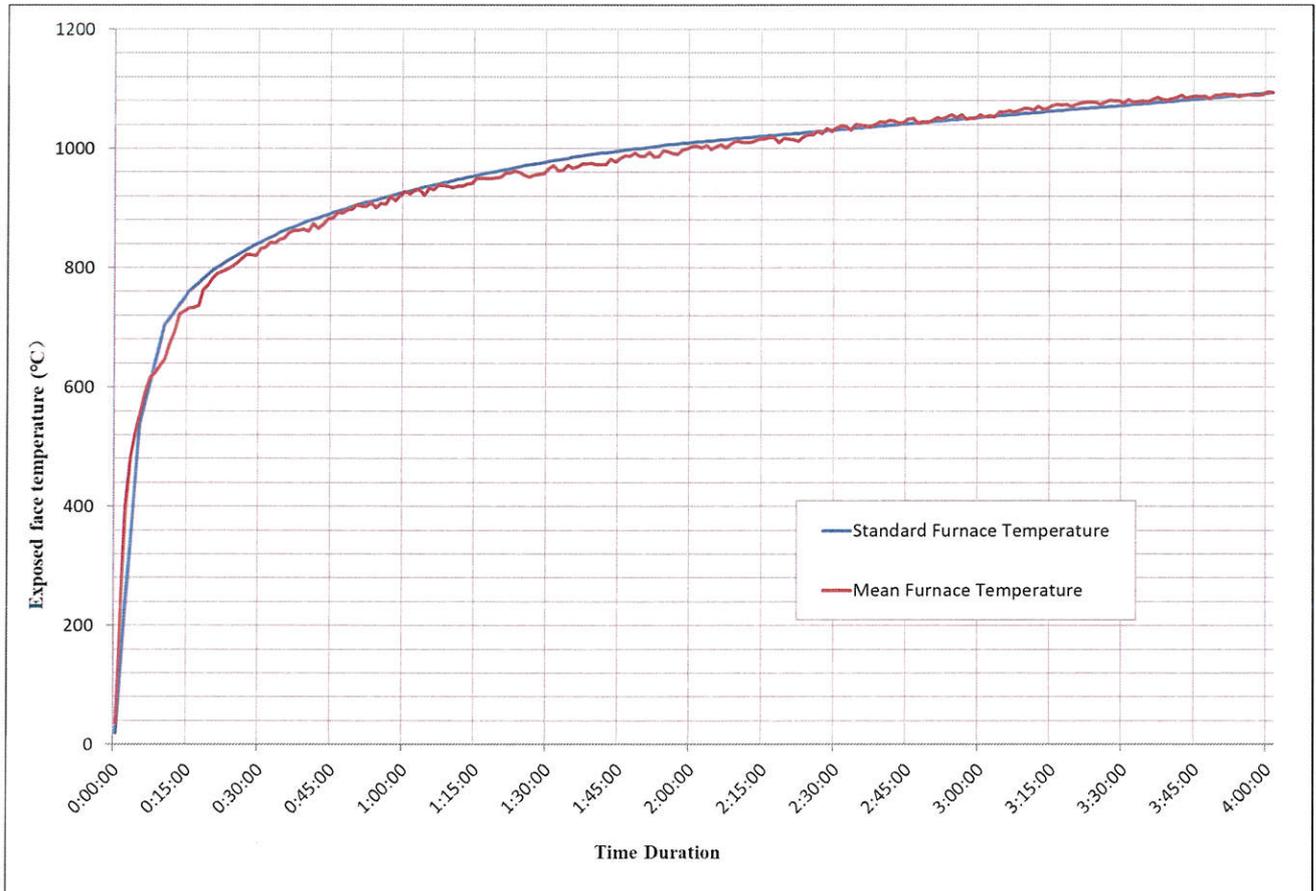
**Figure 3: Measured Furnace Temperature**

The mean measured temperature-time curve of the furnace and the ASTM E119-18a standard fire curve are shown in the **Appendix 3**.

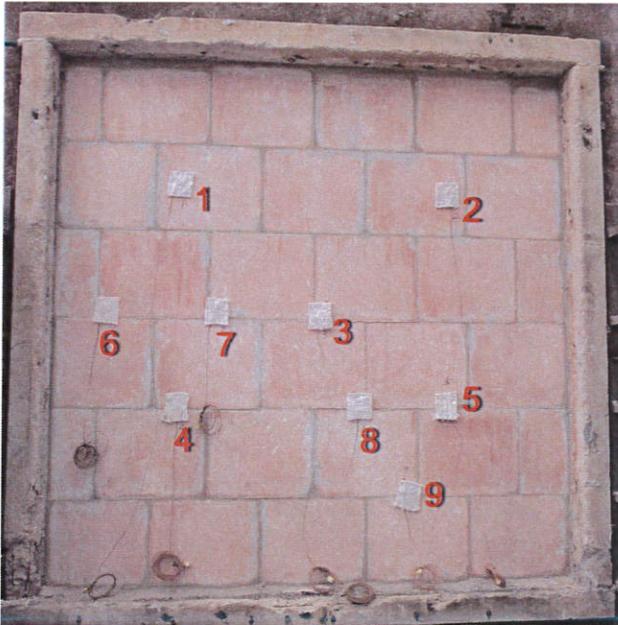
***Figure 4: Locations of Thermocouples on Unexposed Face of Test Specimen***

The unexposed surface of Jumbo Gypsum Block Wall was instrumented with a total of nine (9) Type thermocouples to measure the transmission of heat from exposed surface. The vertical furnace was equipped with nine (9) furnace probes as per ASTM E119-18a. The temperature of the thermocouples and furnace were recorded at one minute interval during the test.

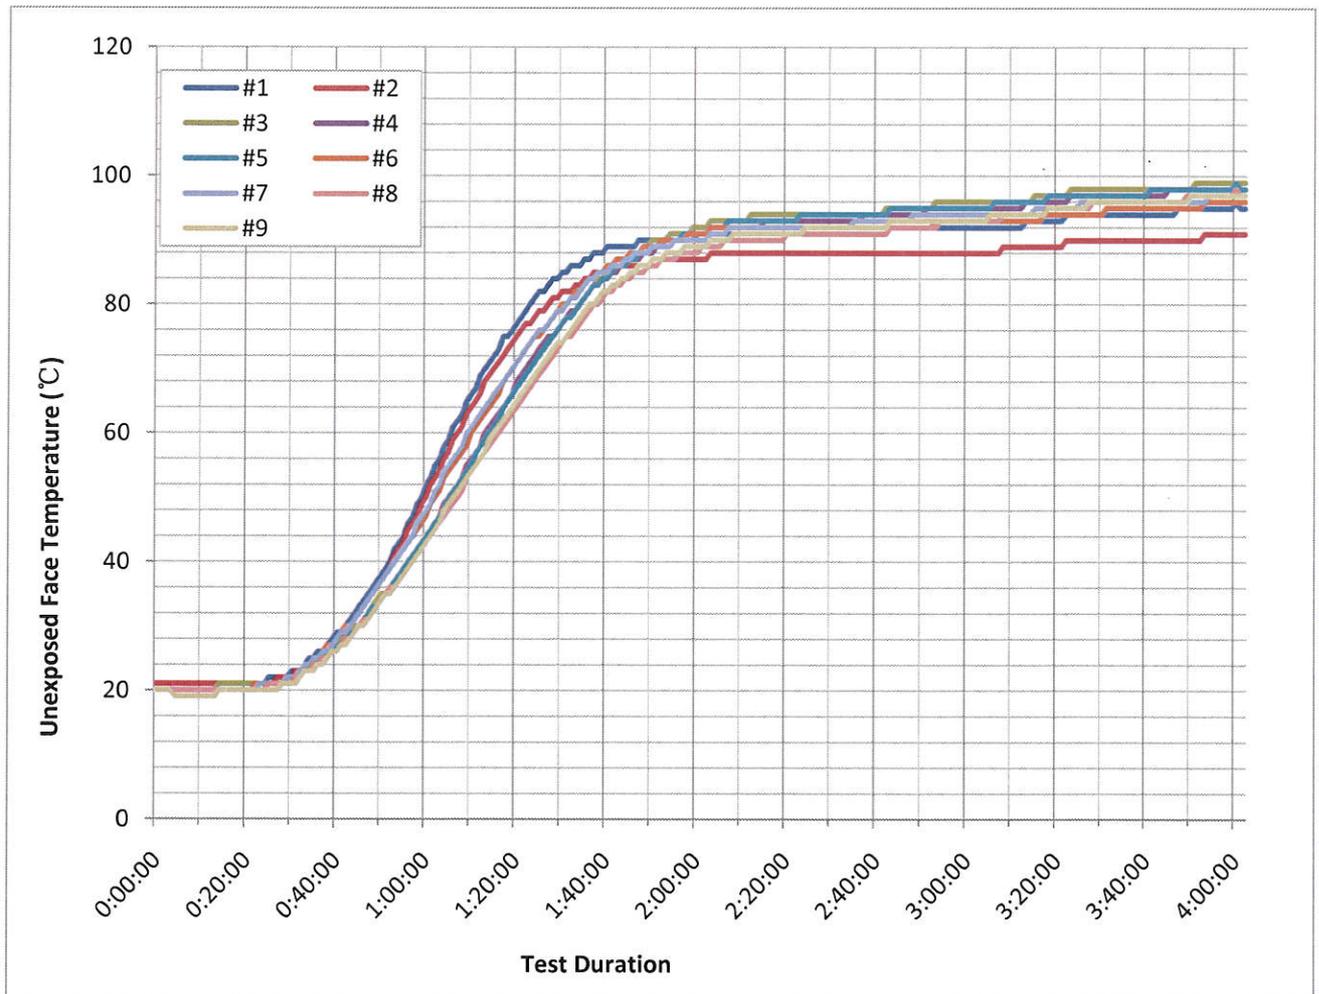
***Figure 5: The measured unexposed surface temperature-time curves***

The mean and maximum measured temperature-time curves at the unexposed face of the test specimen are shown in the **Appendix 4**.

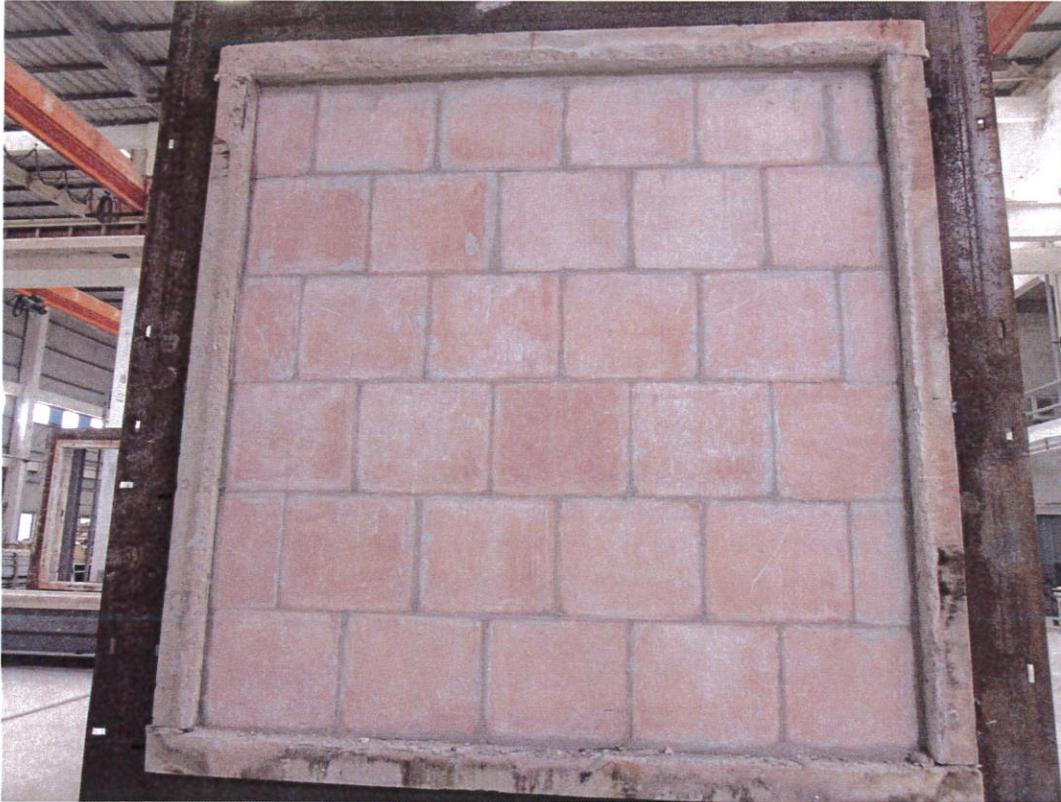
***Figure 6: Photo of Exposed Face before Testing***

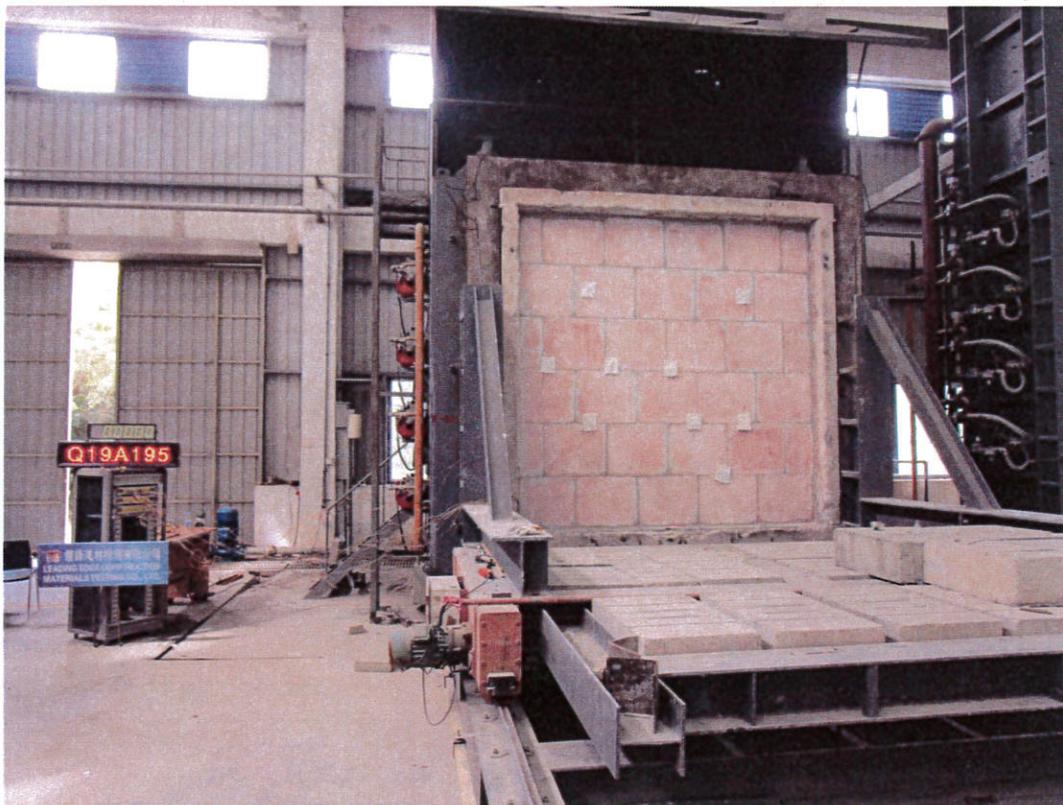
***Figure 7: Photo of Unexposed Face before Testing***

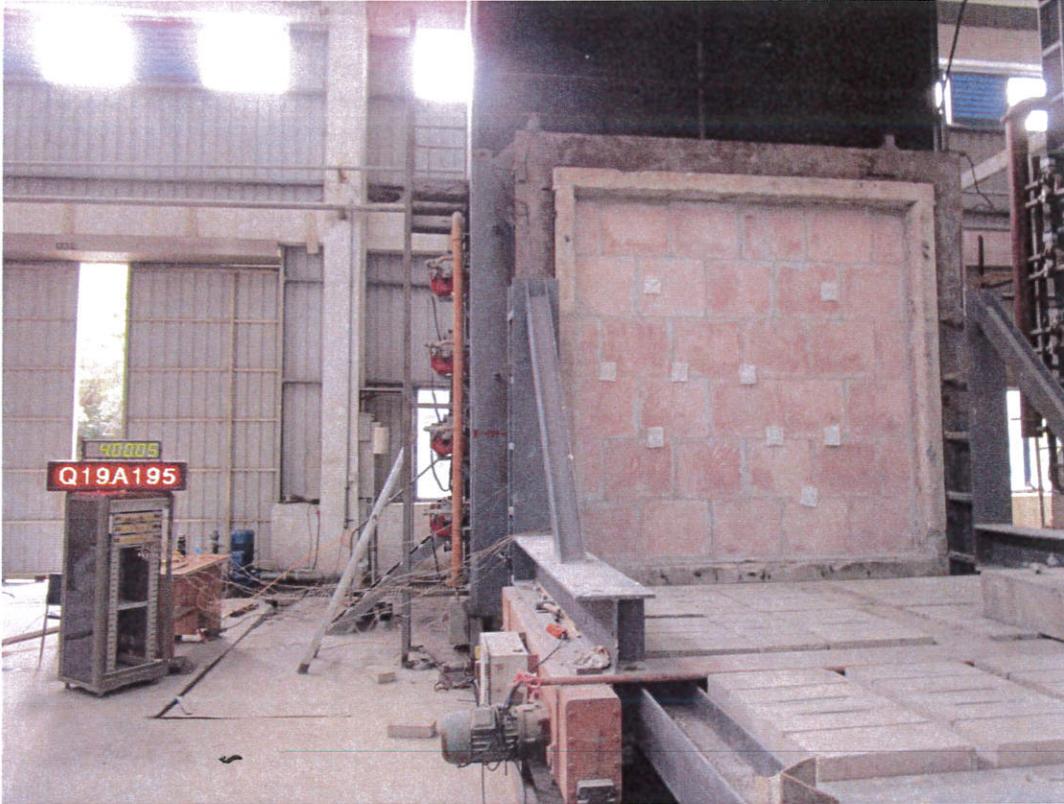
***Figure 8: Photo of Unexposed Face of Specimens after 240 Minutes Testing***

The test specimen has withstood the fire-resistance test without passage of flame or gases hot enough to ignite cotton waste, transmission of heat through the wall during the test was not raise the temperature on its unexposed surface more than 250°F (139°C) above its initial temperature for a period of 240 minutes, and there was no failure in the hose stream test.

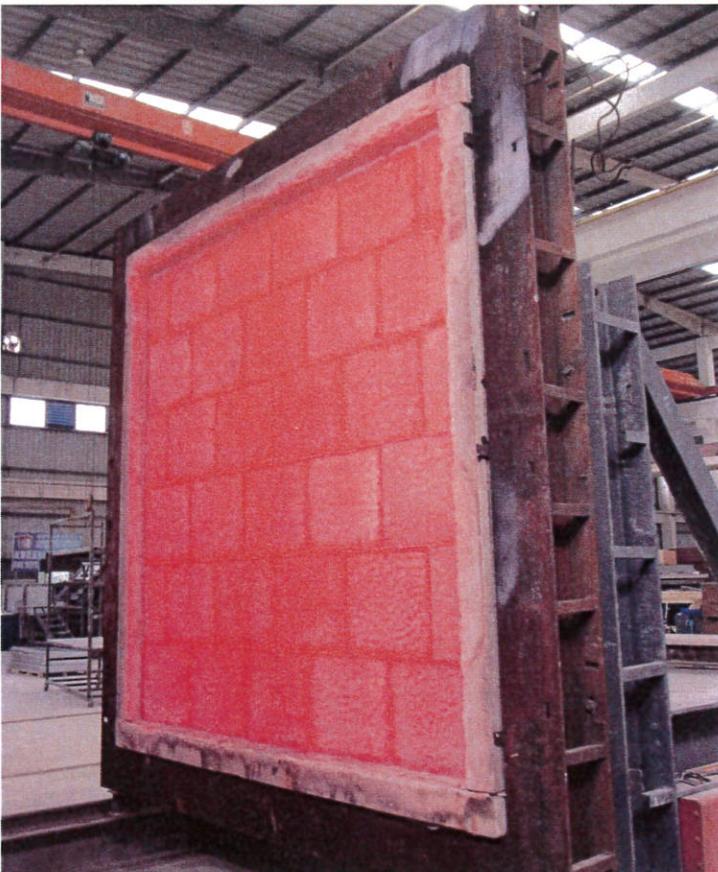
***Figure 9: Photo of exposed face after 240 Minutes Testing***

<b>Time (Minute : Second)</b>	<b>Observations</b>
00:00	Start of test
00:30	No visible change
60:11	No crack or collapse was observed. The temperature rise of the unexposed surface was within the allowable range.
90:00	No visible change
120:09	No crack or collapse was observed. The temperature rise of the unexposed surface was within the allowable range.
150:00	No change
180:12	No crack or collapse was observed. The temperature rise of the unexposed surface was within the allowable range.
240:07	Test ended. No crack or collapse was observed. The temperature rise of the unexposed surface was within the allowable range. Burn mark was observed on exposed face of the specimen.

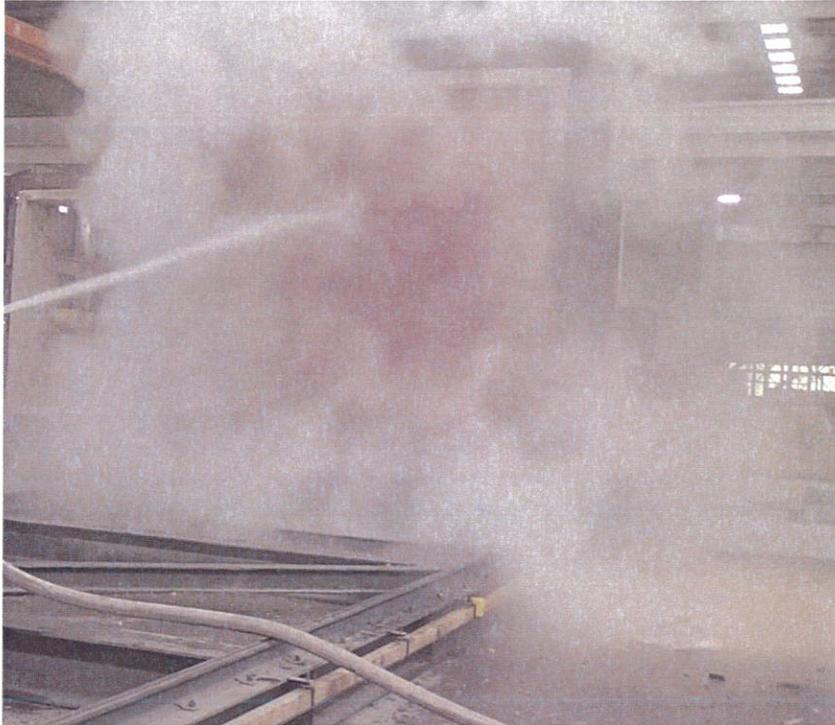
***Figure 10: Hose Stream Test***

The fire resistance test was carried out on 31st Oct 2019 under non loadbearing condition for 4 hours and was then submitted to the ASTM E2226 hose stream test. After the 240 minute fire exposure test, a hose stream was applied to the exposed surface in accordance with the requirements of ASTM E2226.

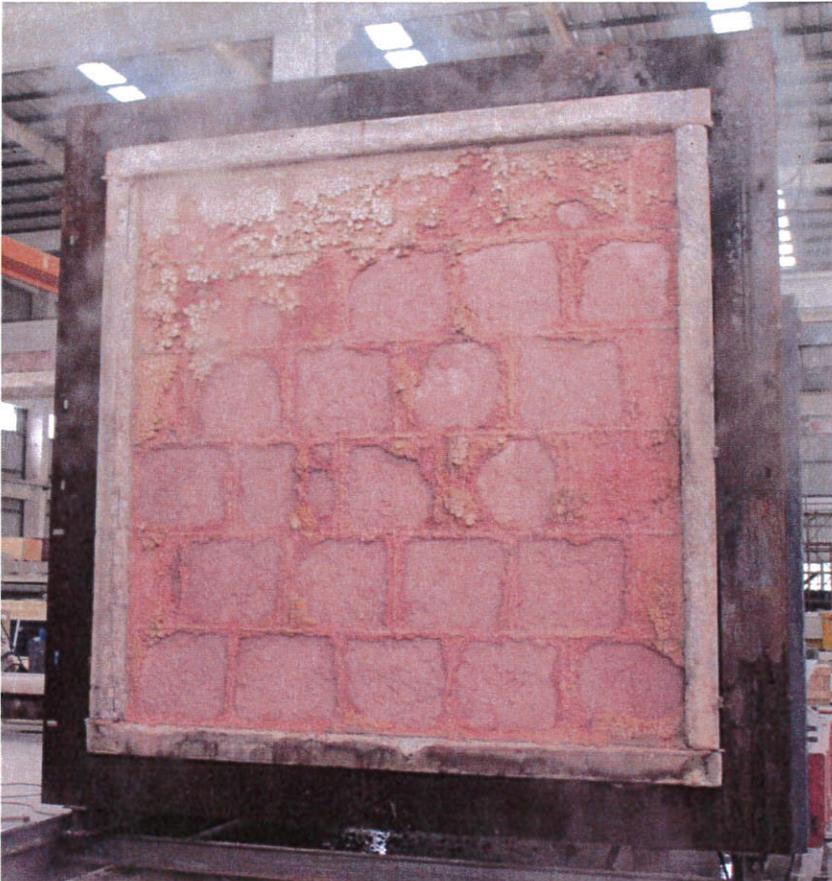
***Figure 11: Photo of exposed face after Hose Stream Test***
