Laboratory Ref. No. : BC0190712-001-MISL

## A Strength and Robustness Test Report

JUMBO Gypsum Partition

Fujian Jumbo New Material Corporation Limited

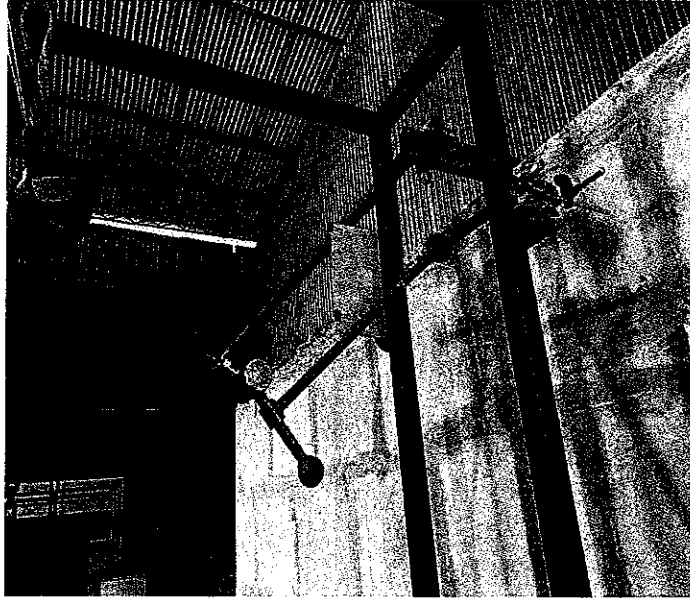
BC0190712-001-MISL

Test method: BS 5234-2: 1992 Annex B

Position	Impact Energy (Nm)	Pendulum head drop height (m)	Angle of swing (°)	Height above the bottom of the specimen (m)	Any indentation, delamination, fracture of surface, etc.	Depth of indentation, if any (mm)	Compliance
<b>Impacts on the faces of the wall partition:</b>							
1	6	0.2	48.2	1.8	No delamination, No fracture of surface	0.899	Depth of indentation < 1.5 mm;  No visible cracking and breakage
2					No delamination, No fracture of surface	1.236	
3					No delamination, No fracture of surface	1.127	
4					No delamination, No fracture of surface	1.234	
5					No delamination, No fracture of surface	1.053	
6					No delamination, No fracture of surface	1.128	
7					No delamination, No fracture of surface	1.146	
8					No delamination, No fracture of surface	1.215	
9					No delamination, No fracture of surface	1.061	
10					No delamination, No fracture of surface	1.201	
<b>Impact at wall partition junction:</b>

11	6	0.2	48.2	1.75	No delamination, No fracture of surface	1.242

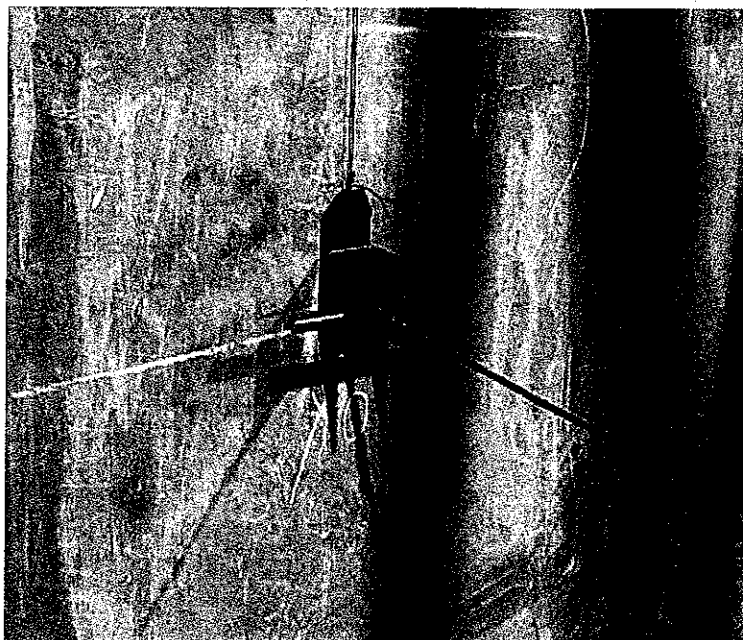
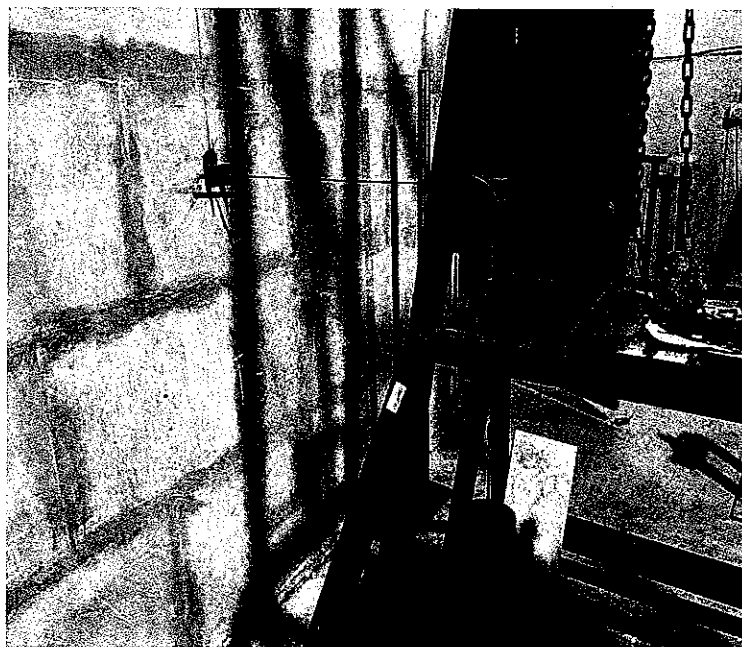
BC0190712-001-MISL

Processes	Time period	Shim plate is released	Any changes or damage to the specimen	Compliance
Apply 20N upward force continuously to the shim plate	--	No	No obvious change and No damage	Without releasing shim plate and no damage to panel.
Apply a load up to 100N to the pull-out test bracket perpendicularly away from the partition by loading equipment	minimum period of 10s	No	No obvious change and No damage	
Sustain the load at 100N	appro. 1 min.	No	No obvious change and No damage	
After remove the load from the pull-out bracket,	--	No	No obvious change and No damage

Anchor Plung : 1 no. of Fischer u x 8 x 50

Fixing Bolt : 1no. of M6 x 65mm

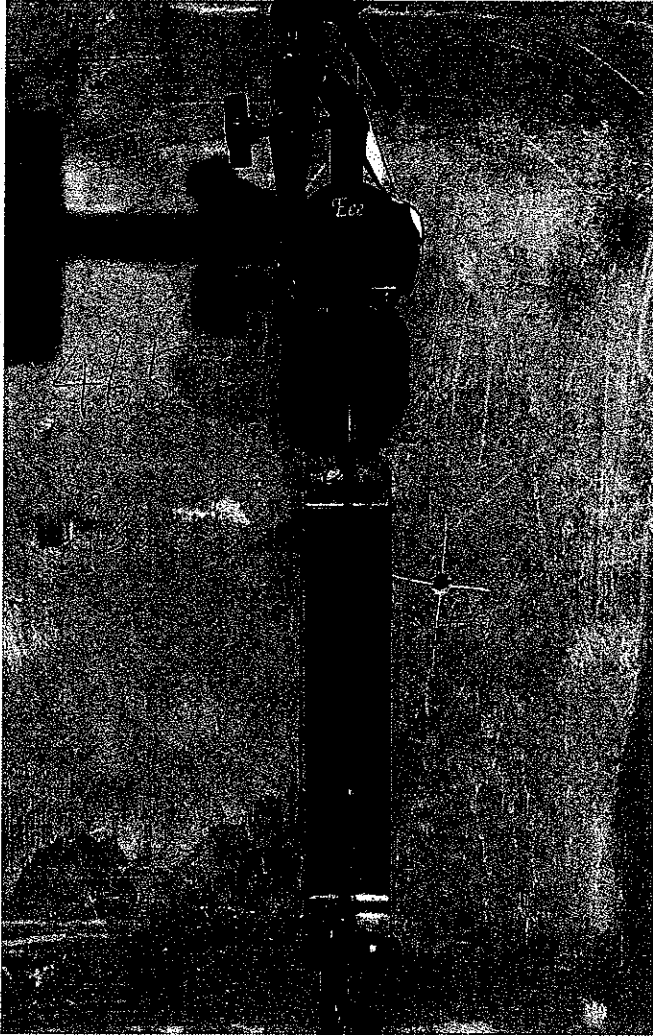
BC0190712-001-MISL

Processes	Time period	Displacement (mm)	Shim plate is released	Any damage or changes to the specimen
Apply 20N upward force to the pull-up shim plate	--	--	No	No obvious change and No damage
Increase an applied load from 0 to 250N gradually to the pull-down test bracket by loading equipment	minimum period of 10s	--	No	No obvious change and No damage
Sustain the load at 250N	appro. 1 min.	0.01	No	No obvious change and No damage
Result after remove the load from the pull-down test bracket:	--	0.00	No	No obvious change and No damage
Compliance	1. Without releasing shim plate, 2. 2mm maximum displacement, 3. no damage to panel

Anchor Plung : 1 no. of Fischer u x 8 x 50

Fixing Bolt : 1no. of M6 x 65mm

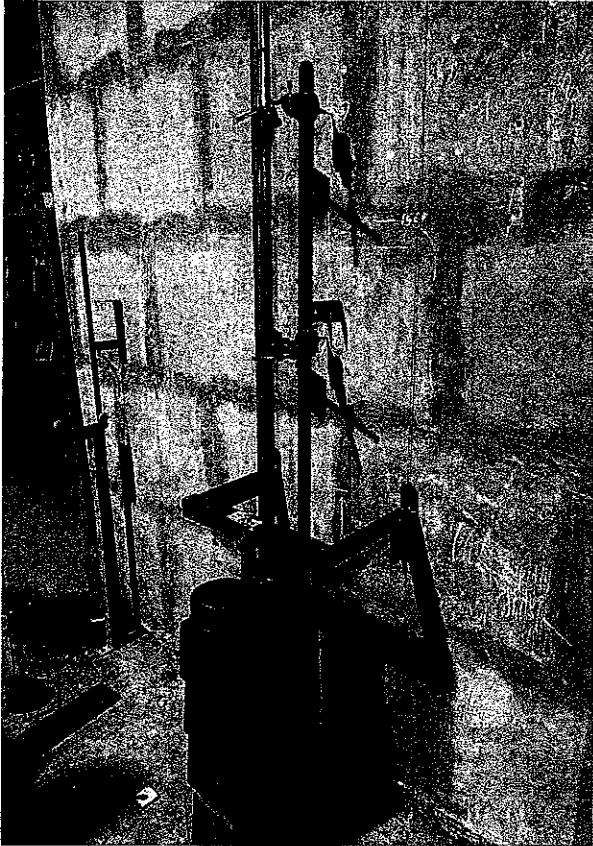
BC0190712-001-MISL

Processes	Time period	Deflection (mm)				shim plate is released	Any damage, loosening, or other changes	
		Front side		Rear side				
		Upper	Lower	Upper	Lower			
Apply 20N upward force to each pull-up shim plate	continuously					No	No Damage	
Apply a preload of 200N gradually and stabilize for:	appro. 1 min.					No	No Damage	
Remove the preload and stabilize for:	appro. 1 min.							
Set the deflection measuring instrument to datum, apply a constant load of 500N to the bar joining the brackets and sustain for:	constantly	0.02	0.01	0.00	0.01	No	No Damage	
Apply and remove load (N)	Total Load (N)							
+250	750	appro. 1 min.	0.03	0.02	-0.01	-0.03	No	No Damage
-250	500	appro. 1 min.	0.03	0.02	-0.01	-0.03	No	No Damage
+250	750	appro. 1 min.	0.03	0.02	-0.01	-0.03	No	No Damage
-250	500	appro. 1 min.	0.03	0.02	-0.01	-0.03	No	No Damage
+500	1000	appro. 1 min.	0.03	0.02	-0.01	-0.01	No	No Damage
-500	500	appro. 1 min.	0.03	0.02	-0.01	-0.01	No	No Damage

Anchor Plug : 1 no. of Fischer S x RL 10 x 60

Fixing Bolt : 1 no. of M7 x 70mm
